Troubleshooting of common faults of gear pumps

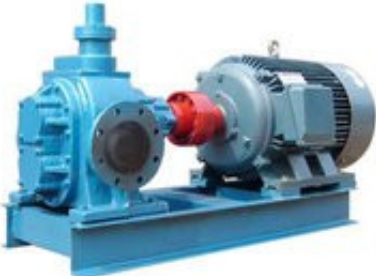
(1) The pump body of [CB-B type gear pump](#) is directly contacted with the two end caps of the hard seal, if the flatness of the contact surface does not meet the requirements, the pump is easy to inhale air at work; Similarly, the end cap of the pump and the pressure cap are also directly contacted, air is also easy to intrude; if the pressure cap is plastic products, the south is damaged or because of temperature changes. Transformation and deformation will also cause severe air leakage. When the flatness of the pump body or the pump cover can not meet the prescribed requirements, it can be grinded back and forth on the flat plate with gold and steel sand according to the "8" curve, or it can be grinded on the surface grinder, so that the flatness does not exceed 5 micron, and it needs to ensure the perpendicularity of the plane and the hole requirements; for the pump cover and the pressure cover; Leakage can be sealed by epoxy resin and other adhesives.

(3) [CB-B gear pump](#) can not be reversed in general, such as reverse pump body, will cause pressure cavity and suction cavity partial short connection, so that its flow reduction or even can not suck oil. At this point, we should check the steering of the pump.
